## General Inspection Report

| <b>Facility Name</b> | SHULL FARM | <b>Operator Name</b> | --- |
| <b>Inspection Type</b> | RTNC - Routine/Complete<br>Inspection | <b>Inspection Result</b> | Violation(s) Noted |

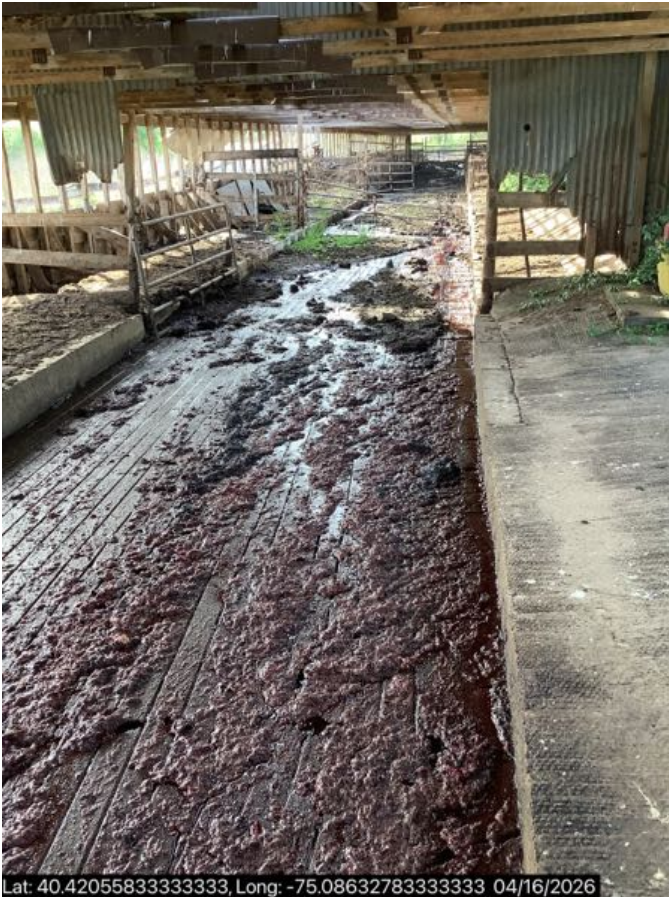
Photo #1 Cattle chute with FPR flow. Taken by Bedhr Salam Majeed 4/16/2026.

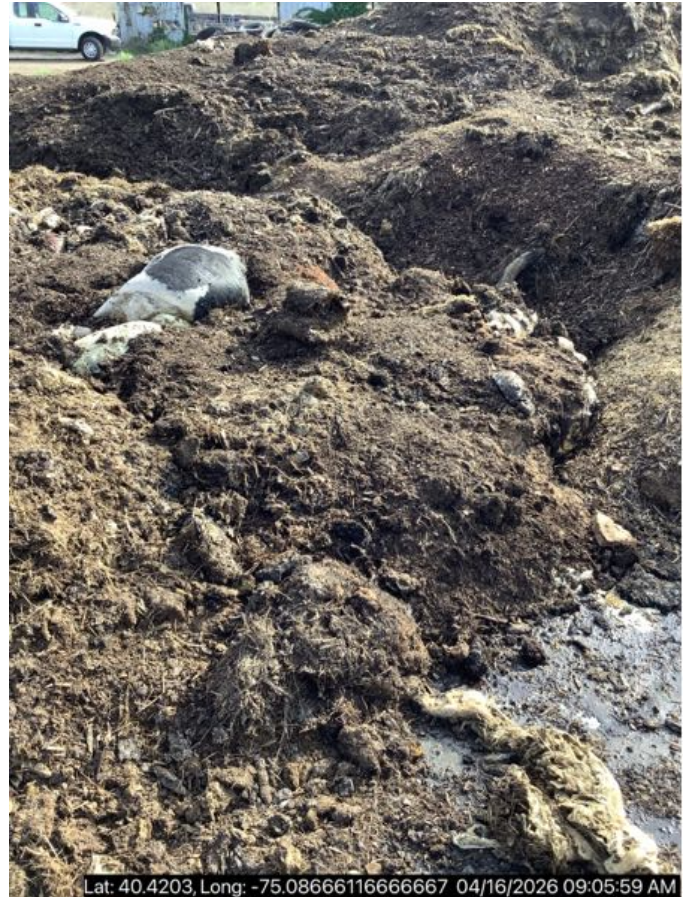
The area down gradient of the compost pad is the manure lagoons. Both impoundments, solid and liquid, were approximately 25% full. Vectors, such as flies and ponding of leachate from the windrow compost piles were observed around the perimeter of the lagoon due to insufficient BMP practices. Directly upgradient of the liquid's lagoon in the old cattle shoot an active flow of a dark liquid was observed running down the shoot and depositing into the liquid's lagoon. At the time of this inspection, it was unclear if this flow originated from the compost area or surface application of FPR. The Department's food processing and residuals manual instructs that operators of FPR impoundments should follow the residual waste storage requirements, related to impoundments. All FPRs should be stored in a manner that complies with Chapter 299 of the Residual Waste Regulations.

The Shull Farm, contrary to 25 Pa. Code 299.115(a)(1), has failed to minimize the harborage, breeding or attraction of vectors.

Photo #2 Insufficiently covered compost creating vectors. Taken by Bedhr Salam Majeed 4/16/2026.

Within seven (7) days of the receipt of this report, the Shull Farm should submit to the Department a plan addressing the cause of the violations and the actions the Shull Farm has undertaken to correct these violations and prevent their recurrence.

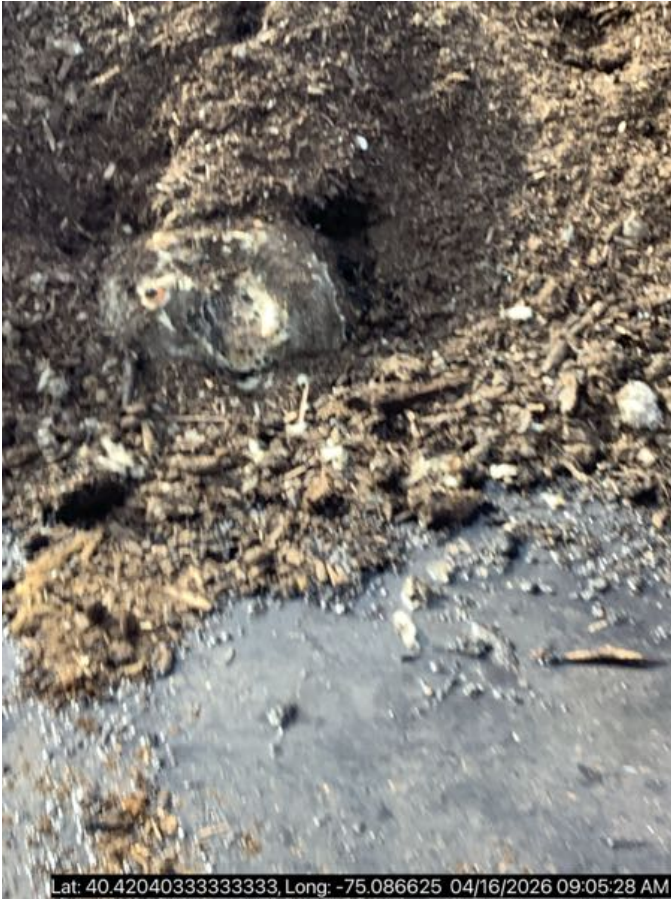
Photo #3 Insufficiently covered compost creating vectors. Taken by Bedhr Salam Majeed 4/16/2026.

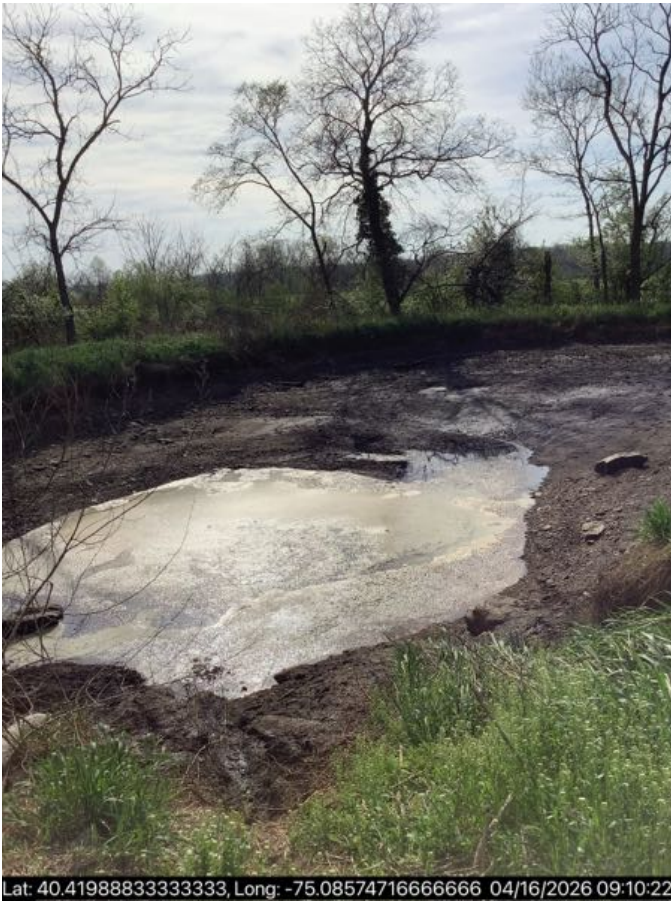
Photo #5 Solids manure lagoon. Taken by Bedhr Salam Majeed 4/16/2026.

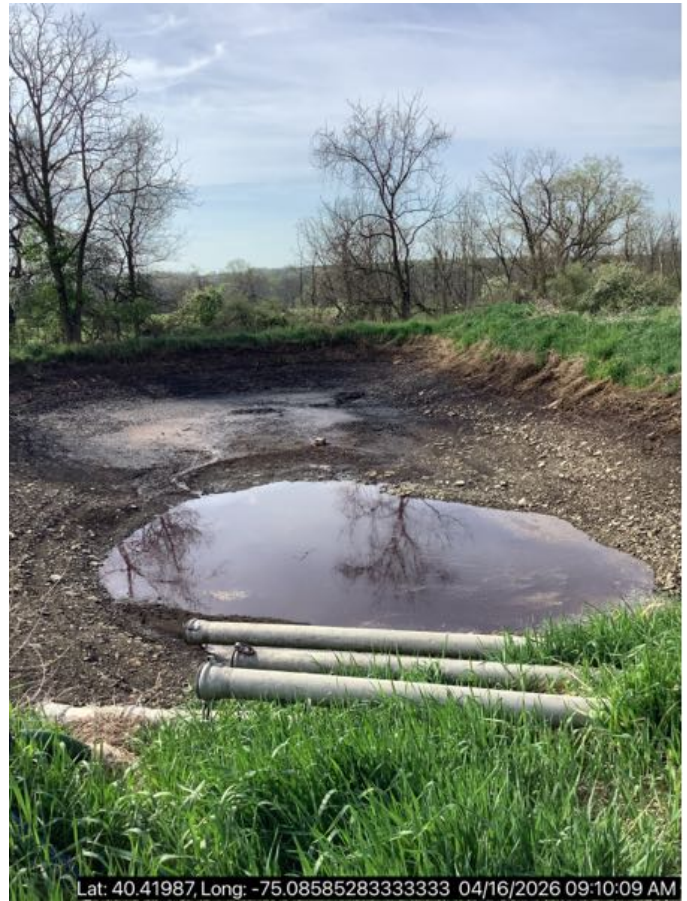
Photo #6 Liquids Manure Lagoon. Taken by Bedhr Salam Majeed 4/16/2026.

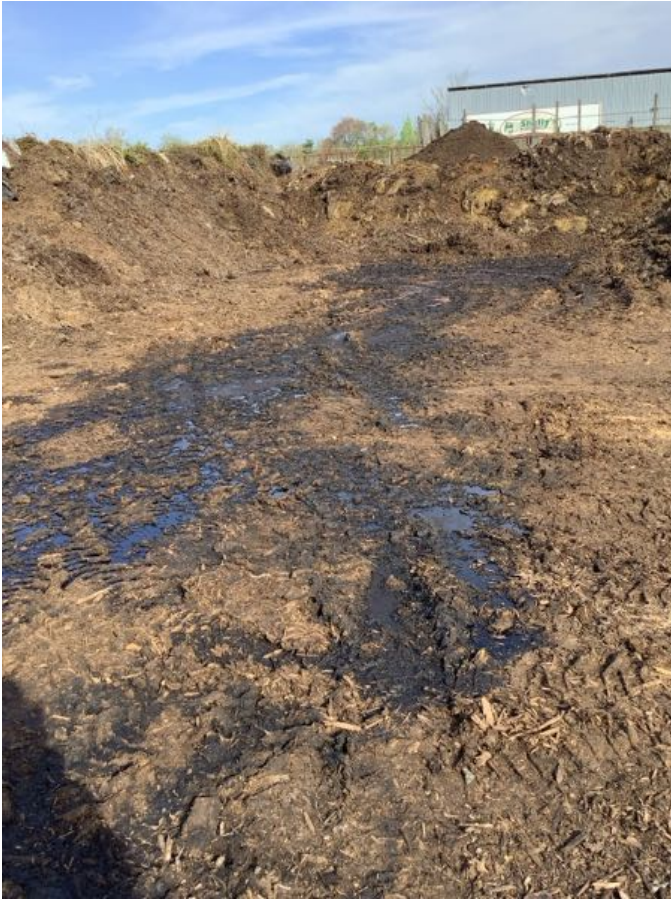
The Shull Farm, contrary to 25 Pa. Code 299.115(b), has stored residual waste and failed to minimize and control conditions that are harmful to public health, public safety or the environment, or which create safety hazards, odors, dust, noise, unsightliness and other public nuisances.

Photo #7 Standing leachate creating vectors.  
Taken by Bedhr Salam Majeed 4/16/2026.

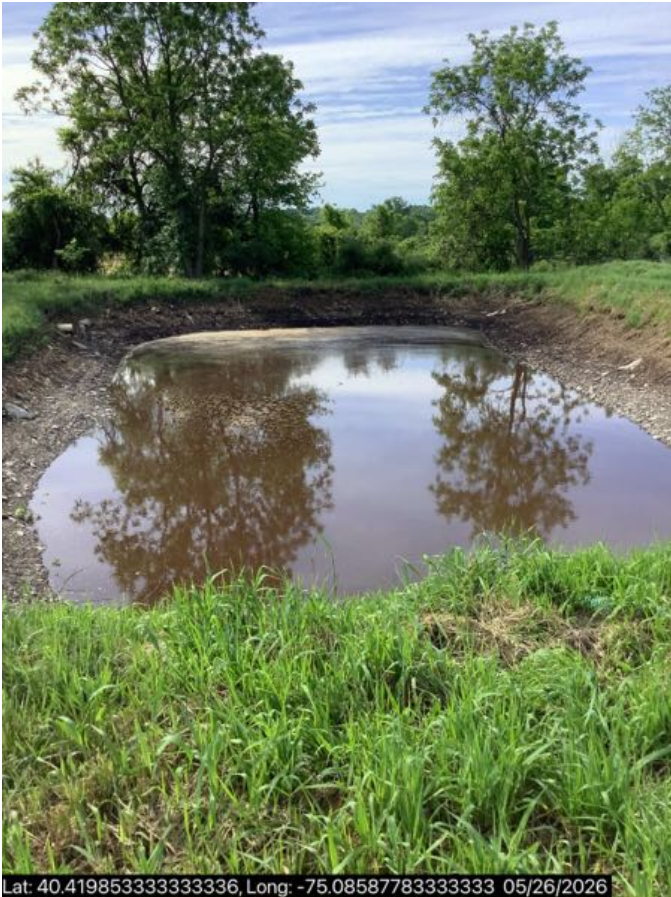
The inspection led to the solid and liquid manure lagoons. A recent deposit of cheese whey from Lebanon Cheese the morning of this inspection was mentioned by Mr. Art Shull. The solids manure lagoon was observed to be approximately 50% full. The liquid manure lagoon was observed 25% full. Cheese Whey will be utilized as fertilizer for surface applications on the Shull Farm. The Shull Farm should ensure the application, storage, and odor control of the cheese whey is completely and appropriately incorporated into their land application and FPR plans and revise them as needed. No runoff from the lagoons was observed at this time with a vegetated buffer observed between the lagoons.

Photo #1 Liquid manure lagoon.

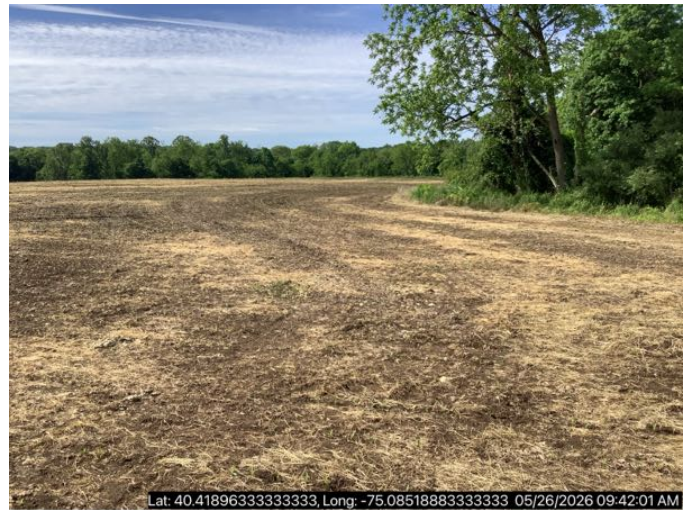
On May 20th, 2026, at 6:18AM, Ephraim Stoltzfus – Owner of Kingdom Provisions, provided pictures via email of the impacted south field area being mitigated including pictures of the material introduced back into the windrow compost piles for further processing. At the time of this inspection the area in the south field where compost had been spread, potentially within the setback of an unnamed tributary was observed to be “disked” or further tilled in and corn has been planted.

Photo #2 Area of discing and crops implemented near unnamed tributary.

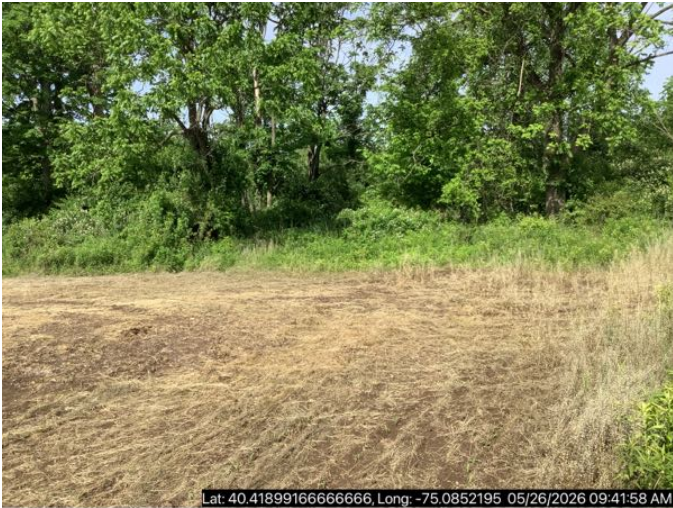
Photo #3 Area of discing and crops implemented near unnamed tributary.

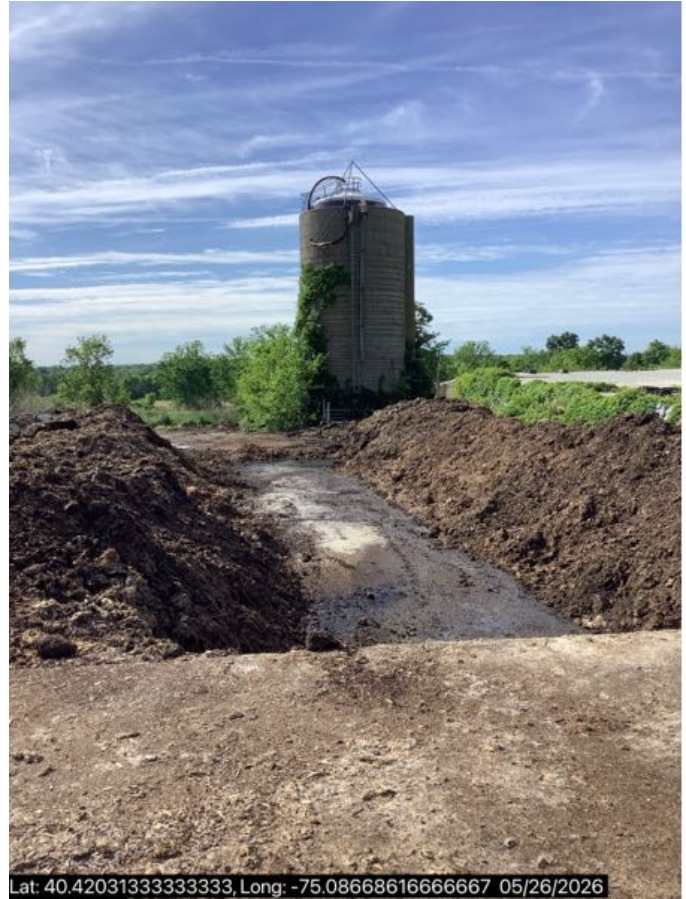
Upon arrival, we proceeded to the composting pad area. It is noted that there was significant rainfall in this area on the weekend of May 22nd through May 25th. Mr. Shull stated that the mitigation of the puddling leachate after the rainfall was left untouched due to tracking of mud and their efforts to show DEP and BCCD progress on the grading of the compost area. Once at the windrow compost piles all piles were observed to be turned and covered with no carcasses or FPR uncovered. One (1) stacked pile located on the upper concrete pad and four (4) windrow piles on the lower concrete pad were observed. Composted material was arranged from the oldest material to freshest material from East to West on the concrete pad with the upper concrete pad stacked pile being the most recent material accepted at the site. The windrow compost piles were approximately 8ft high by 10ft wide while the stacked pile was approximately 6ft high by 10ft wide. Odors around the stacked and windrow compost piles were determined to be non-offensive. No evidence was observed of material being added to the compost piles since my 4/29/2026 inspection. No turkey vultures were observed flying or observed on the windrow piles. Swarms of flies were no longer observed around the windrow piles.

Standing puddles of dark leachate were observed around the perimeter of the windrow compost piles and barn area leading to the impoundments. This is contrary to Chapter 25 PA Code 299.115(b), in that "a person or municipality storing residual waste shall also minimize and control conditions not otherwise prohibited by this subchapter that are harmful to the public health, public safety or the environment, or which create safety hazards, odors, dust, unsightliness or other public nuisances" and Chapter 25 PA Code 299.111(4), in that a person or municipality that stores residual waste may not allow waste or constituents of waste to be blown or otherwise deposited outside of the storage area. Mr. Shull was advised leachate puddles will need to be absorbed with the absorbent material being reintroduced into the windrow compost piles or disposed of properly. Mr. Shull was also advised to contact engineers previously used at Rosetree Consulting LLC as the Shull Farms engineering design may need corrections and updates reflecting the status of the site and any further construction being implemented for future use of the site.

Photo #4 Compost windrow piles.

On May 27th, 2026, at 11:17AM, Mr. Bootie, Kingdom Provisions Operations Manager, provided pictures via email confirming the absorption of leachate puddles throughout the composting site with reintroduction into the windrow piles correcting these violations.

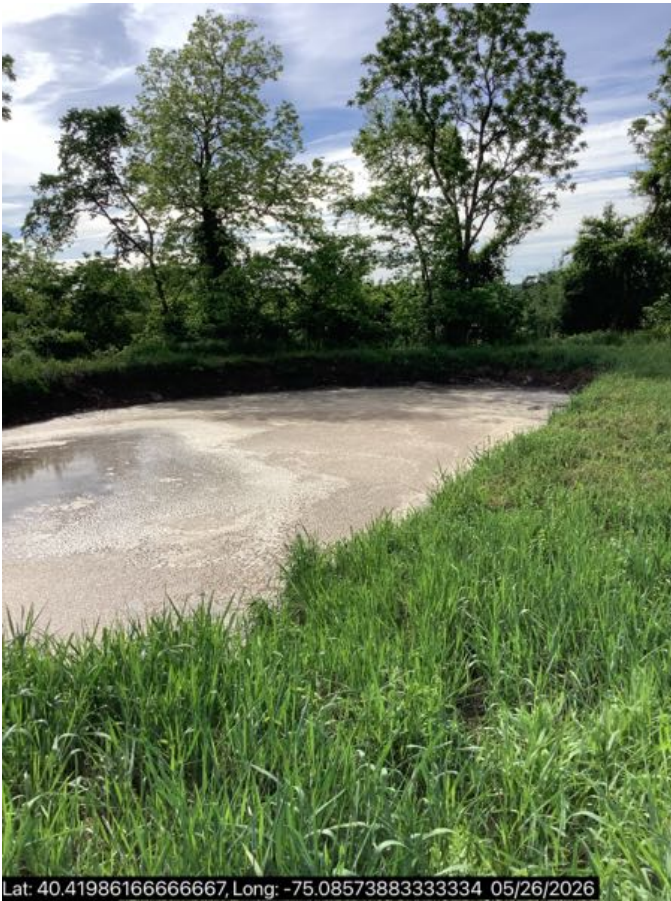
Photo #5 Solids manure lagoon.

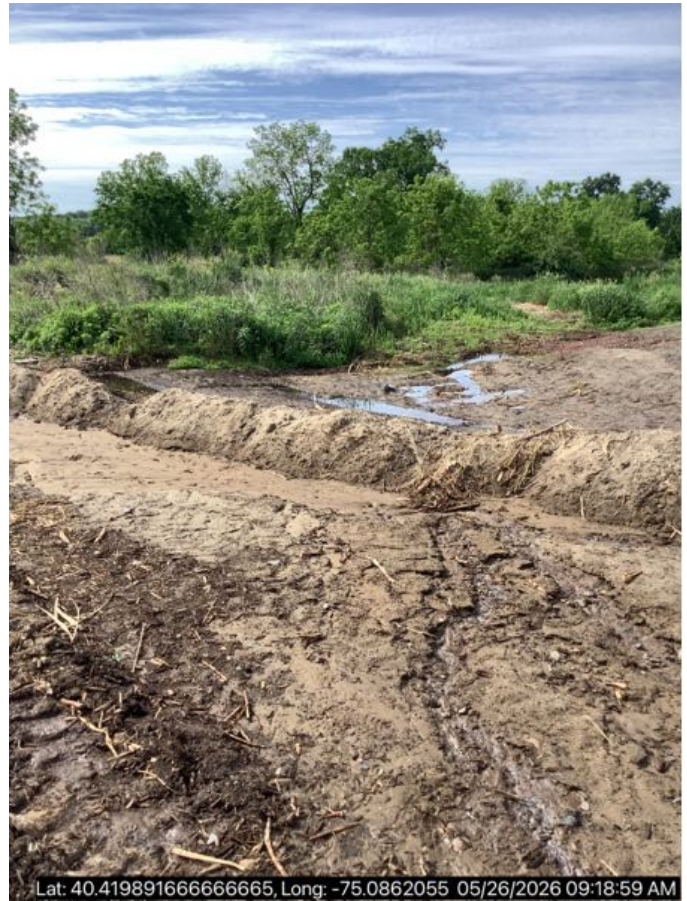
Photo #6 Regraded area.

Comment: Puddling of leachate material observed, photos received 5/27 of materials absorbed and area regraded.

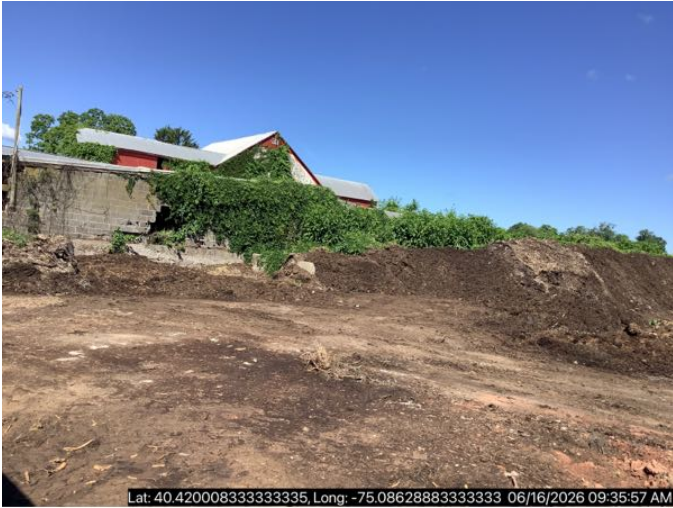
Upon arrival, I proceeded to the composting pad area. Once at the windrow compost piles all piles were observed to be turned and covered with no carcasses or FPR uncovered. One (1) stacked pile located on the upper concrete pad and four (4) windrow piles on the lower concrete pad were observed. Composted material was arranged from the oldest material to freshest material from East to West on the concrete pad with the upper concrete pad stacked pile being the most recent material accepted at the site. The windrow compost piles were approximately 8ft high by 10ft wide while the stacked pile was approximately 6ft high by 10ft wide. Odors around the stacked and windrow compost piles were non offensive. No evidence was observed of material being added to the compost piles since my 4/29/2026 inspection. No turkey vultures were observed flying or observed on the windrow piles. Swarms of flies were no longer observed around the windrow piles. No standing puddles of dark leachate were observed around the perimeter of the windrow compost piles or barn area leading to the impoundments.

Photo #5 Oldest windrow compost pile and regraded area next to barn.

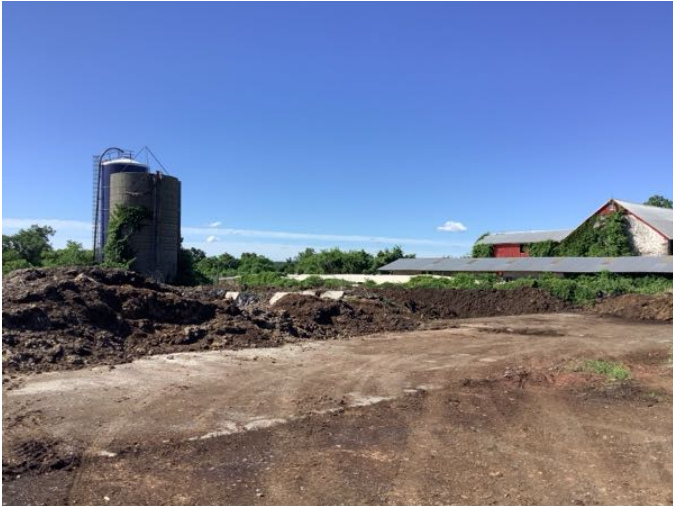
At the time of this inspection the exposed section of the upper level concrete pad measuring approximately 20ft by 10ft, was observed to be free of visible cracks, deterioration, or evidence of leakage into the surface. No signs of settlement were observed. However, further investigation of the entirety of the upper-level concrete pad is still needed to fully evaluate its overall condition and to determine structural integrity.

Photo #1 Top pad compost pile.

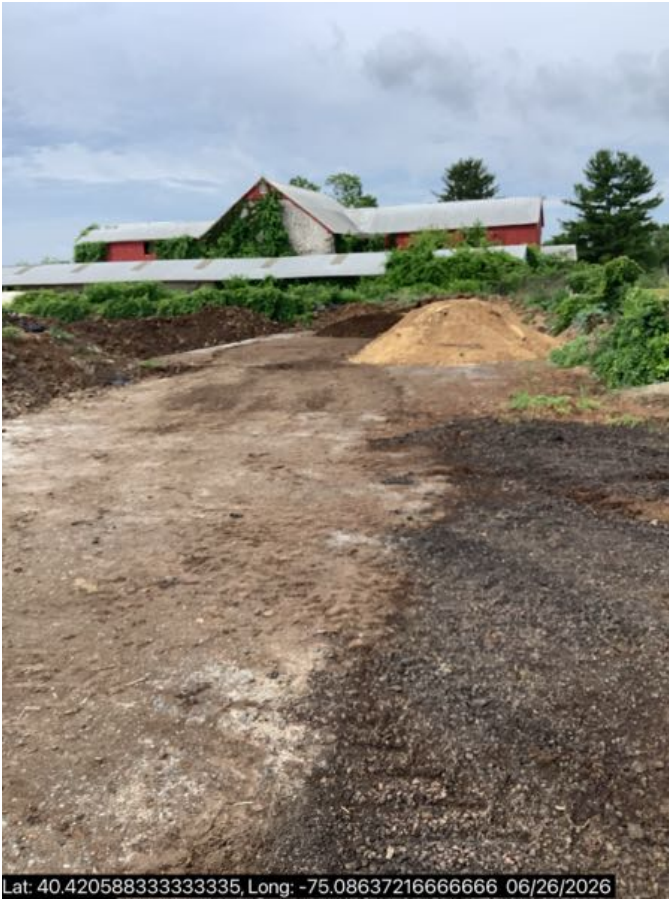
At the time of this inspection the exposed section of the upper-level concrete pad measuring approximately 20ft by 10ft, was observed to be free of visible cracks, deterioration, or evidence of leakage into the surface. No signs of settlement were observed. However, further investigation of the entirety of the upper-level concrete pad is still needed to fully evaluate its overall condition and to determine structural integrity.

Photo #1 Upper concrete pad.

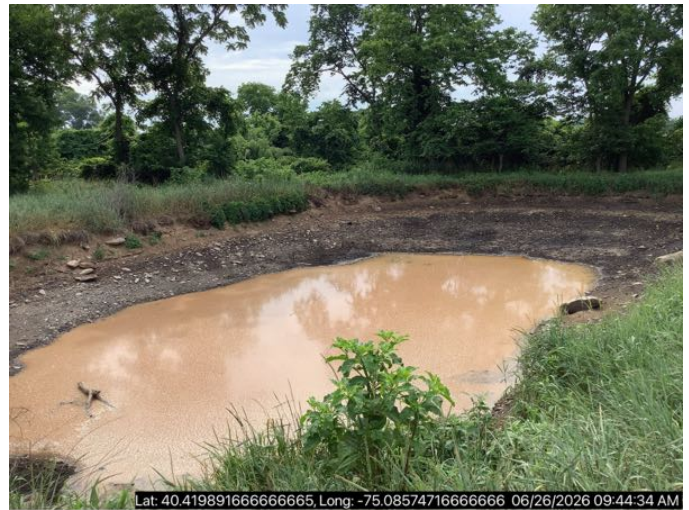
The inspection led to the solid and liquid manure lagoons. The solids manure lagoon was observed to be approximately 10% full. The liquid manure lagoon was observed 10% full. Cheese Whey will be utilized as fertilizer for surface applications on the Shull Farm. Deliveries are stated only to be made when needed to reduce odors in the area. The Shull Farm should ensure the application, storage, and odor control of the cheese whey is completely and appropriately incorporated into their land application and FPR plans and revise them as needed. No runoff from the lagoons was observed at this time with a vegetated buffer observed between the lagoons. No offensive odors were observed at the lagoon area.

Photo #2 Solid FPR lagoon 10% filled.

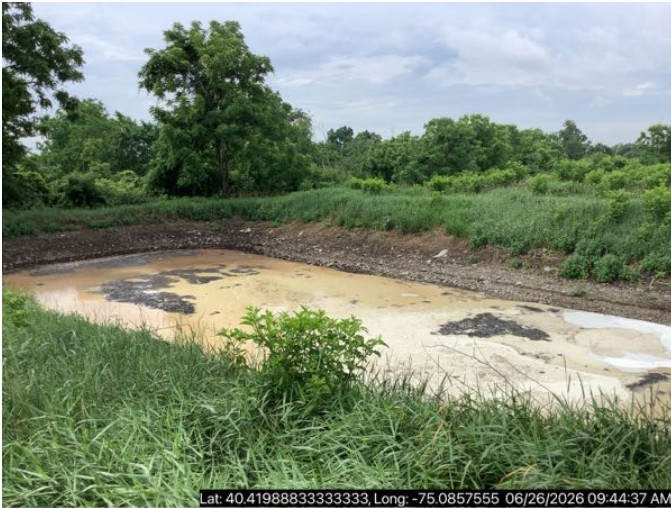
Photo #3 Liquids FPR lagoon 10% full.

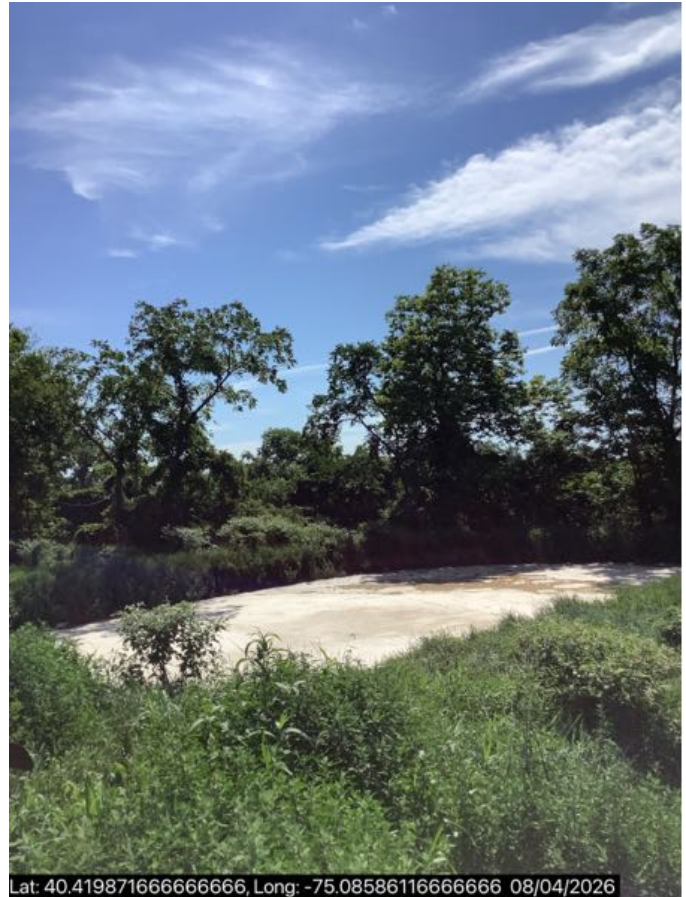
The inspection led to the solid and liquid manure lagoons. Minor soured milk/cheese odors were observed directly around the perimeter of the lagoons. The solids manure lagoon was observed to be approximately 75% full of cheese whey. The liquid manure lagoon was observed approximately 75% full of cheese whey. Cheese whey will be utilized as fertilizer for surface applications on the Shull Farm. Deliveries are stated only to be made when needed to reduce odors in the area. The Shull Farm should ensure the application, storage, and odor control of the cheese whey is completely and appropriately incorporated into their land application and FPR plans and revise them as needed. No runoff from the lagoons was observed at this time with a vegetated buffer observed between the lagoons. No offensive odors were observed at the lagoon area.

Photo #2 Solids manure lagoon approximately 75% full of cheese whey.

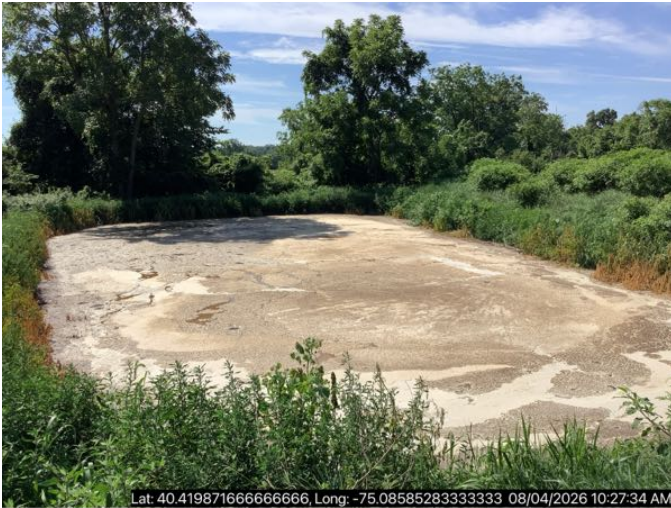
Photo #3 Liquids manure lagoon approximately 75% full of cheese whey.

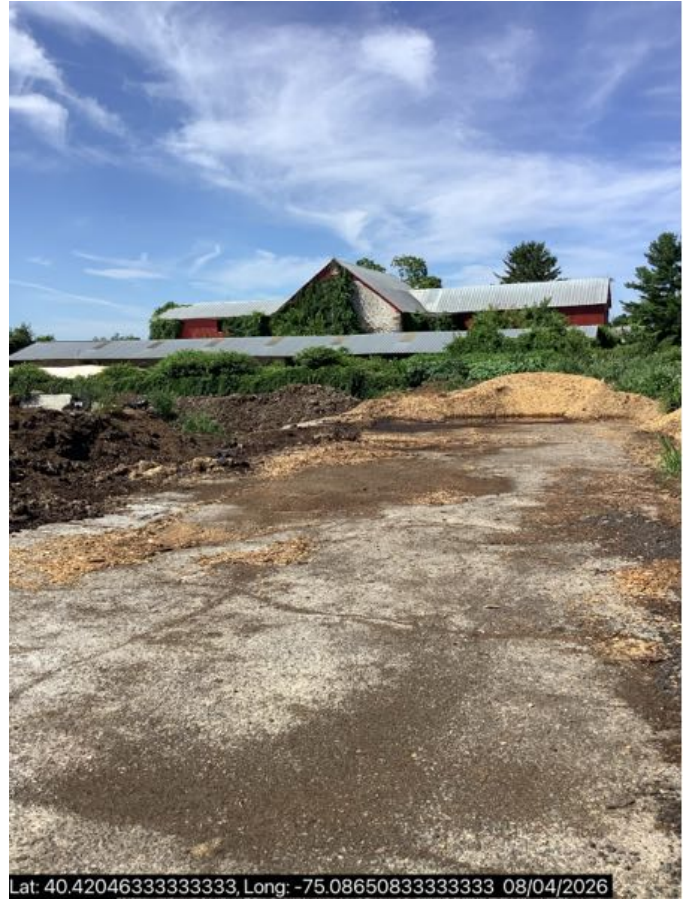
At the time of this inspection the exposed section of the upper-level concrete pad measuring approximately 20ft by 10ft, was observed to be free of visible cracks, deterioration, or evidence of leakage into the surface. No signs of settlement were observed. However, further investigation of the entirety of the upper-level concrete pad is still needed to fully evaluate its overall condition and to determine structural integrity.

Photo #4 Top concrete pad area.
