Commonwealth of Pennsylvania  
Department of Environmental Protection  
September 14, 2026

Subject: Aquatic Biology Investigation  
Case: Shull Farm FPR Operation  
UNT Geddes Run  
Plumstead Township, Bucks County

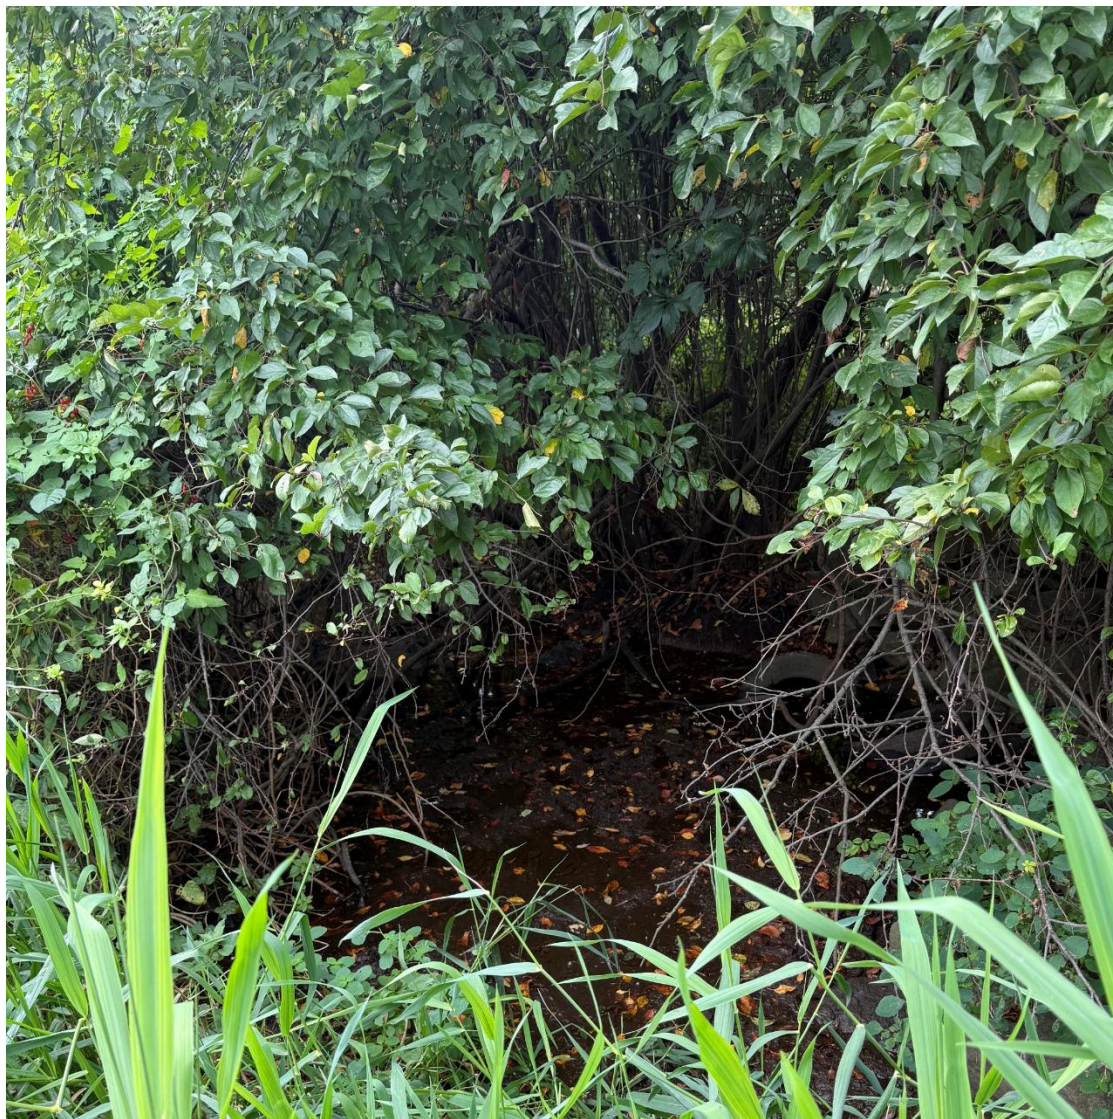
The area behind the lagoons near the beginning of the formation of UNT Geddes Run was observed. Plant growth including grasses and jewelweed was much higher compared to the previous visit and seep areas were not as prominent. Some areas of standing water and mud in channels in the grass were found and the pooled area observed during the previous visit was mostly mud with some water (Photo 1). No dark colored seeps were observed. Mostly standing water with areas of very small flow were observed where the drainage became a more consistent channel further down gradient. No undesirable algal growth or sewage fungus was observed in the channel. A drainage channel with consistent bed and banks was observed with a small amount of flow emanating from the pond up gradient of the lagoons. Some filamentous green algal growth was observed in the channel at that location.

Photo 1: Pooled area behind the lagoons.

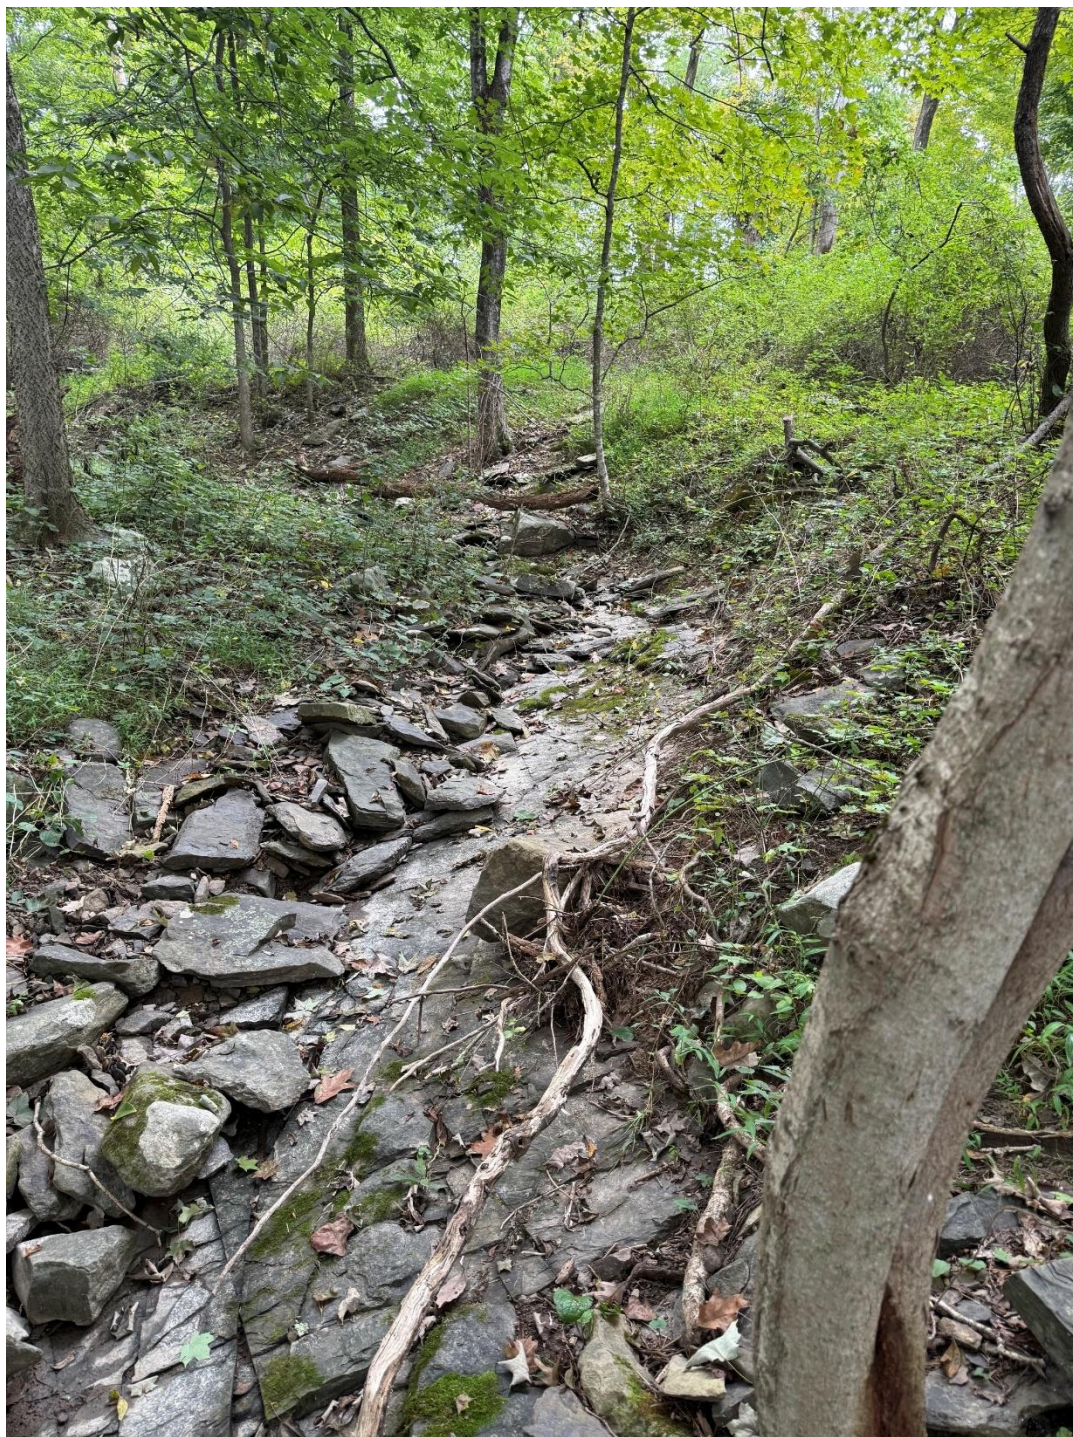
UNT Geddes Run was also observed near Tollgate Road after leaving the lagoon area (Photo 2). Unlike the previous visit, there was no flow observed in the channel with only small areas of standing water present. Dry areas in the channel bed had a white appearance indicative of dried biofilm and algal growth.

Photo 2: UNT Geddes near Tollgate Road.

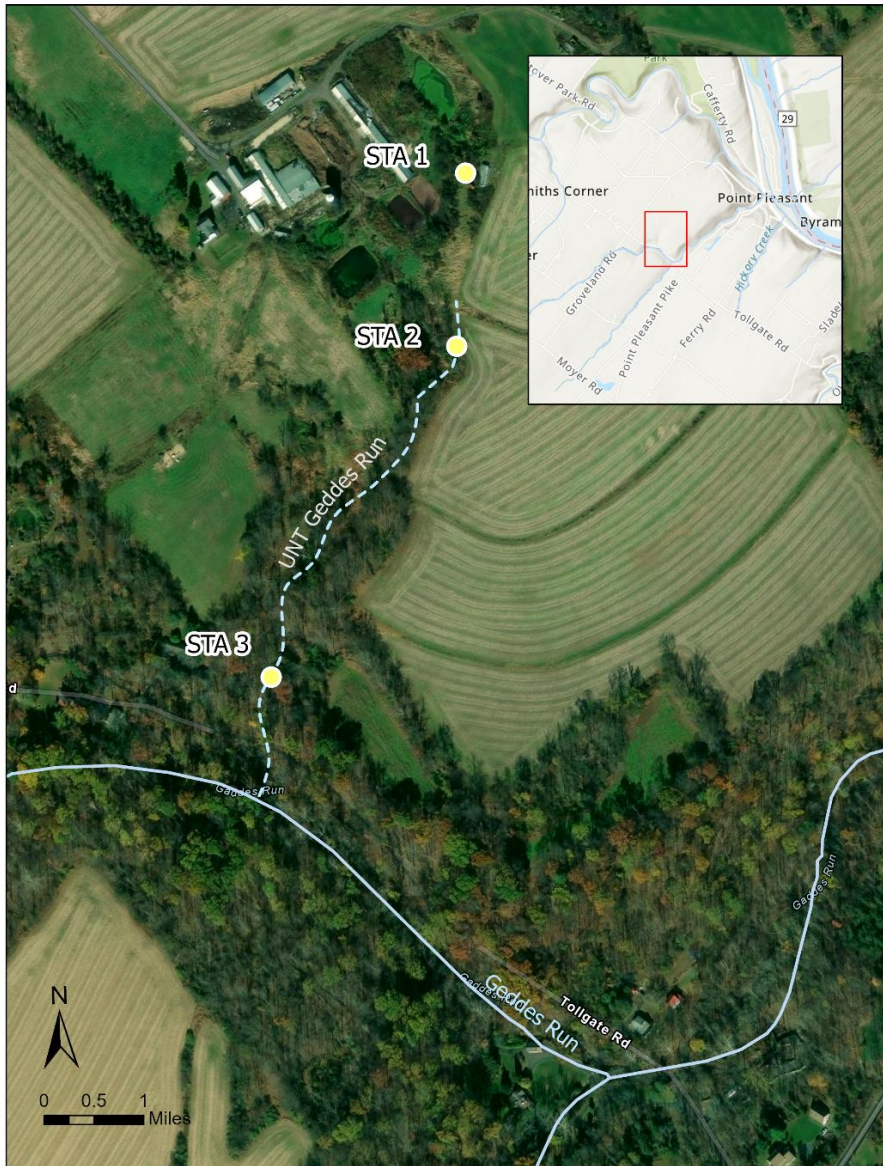
Field meter readings were taken at three locations (Figure 1) including in the channel upstream of the lagoons (STA1), where the channel formed downstream of the lagoons (STA2), and in a pooled area in the UNT at Tollgate Road (STA3). Dissolved oxygen was higher in the channel at STA2 compared to the previous visit and comparable to the channel from the pond (STA1) and downstream near Tollgate Road (STA3). Conditions of UNT Geddes near the lagoons seemed improved with no observed impacts from the FPR operation runoff or seeps likely caused by operational changes and hydrological differences since April.

Figure 1. Aerial imagery showing field meter reading locations. Solid blue lines are NHD Plus V2 flowlines. Dashed blue line added by writer.
